# APPLICATION NOTE

## LOW-COST IMPROVEMENTS FOR TIRE PRODUCERS Tension Control Delivers Scrap Reduction & Improved Quality

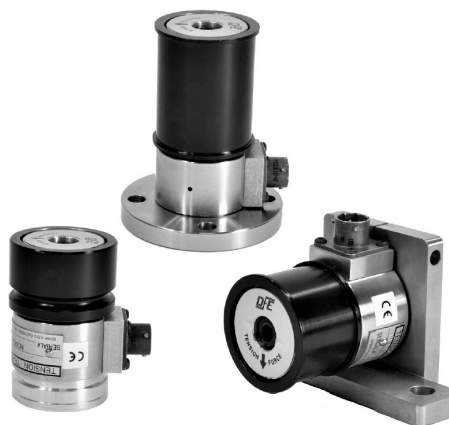
### RFA Tension Transducers

The new system incorporated 12 RFA (Ribbon-Filament) tension transducers with tension amplifiers and 12 display meters to monitor running tension continuously on each wire. Small manual adjustments to the tensioning device are still made by operators when deviations in wire tension are noted throughout the process.

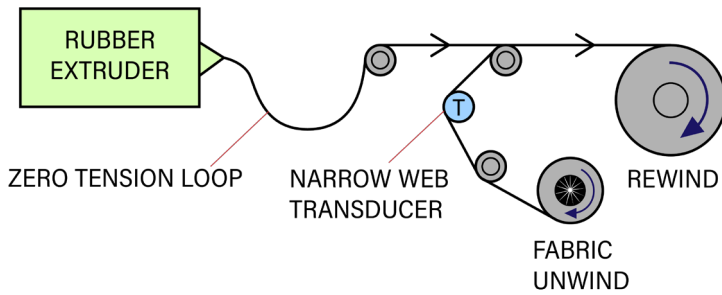
Figure 1

In another of the early tire-making subprocesses, latex impregnated rubber sidewall material is extruded and wound onto reels for further processing. The winding is performed at very low (almost zero) tension to avoid stretching the material. In its uncured state, the latex impregnated rubber is very tacky, so as it is wound onto its reel a fabric backing/liner is applied. This keeps each layer of rubber separated from the next. See figure 1.

Tension on the moving fabric liner, as it comes together with the rubber, should be controlled for two reasons:

- 1) If too little tension is applied during winding, the fabric tends to bunch, wrinkle or fold over as it is being taken up into the reel with the sidewall material.
- 2) If too much tension is created, the fabric tends to dig into the soft rubber leaving a deep textured pattern.

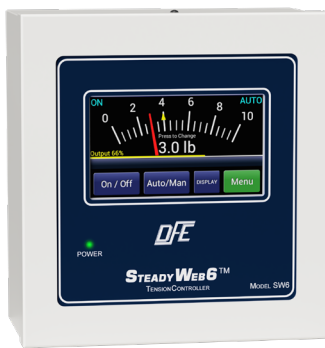
### SteadyWeb™ 6 Automatic Tension Controller

To solve the problem, a pneumatic brake was used on the fabric liner unwind in conjunction with an automatic tension controller, and a 25 pound load-rated 14" Narrow Web transducer measuring 12 pounds of tension. With this system, the customer was able to successfully reduce the process waste level from approximately 25% to less than 1%.
